# Internal Pitting Corrosion

**Cokebusters Ltd** were requested by a reputable global group of refining companies to carry out a Merlin™ in-line inspection of three separate sections of 6-inch furnace tube. The three sections of tubing had been removed from the furnace due to the presence of severe internal pitting corrosion. The aim of the investigation was to observe the geometric data acquired from the Merlin intelligent pig within these corroded areas. The three sections of tubing were sent to the Cokebusters Technology Centre (UK), where the tests were conducted. The inspection was carried out using the patented Merlin™ Intelligent In-line inspection, or intelligent pigging system for accurate geometric assessment of the tube sections.

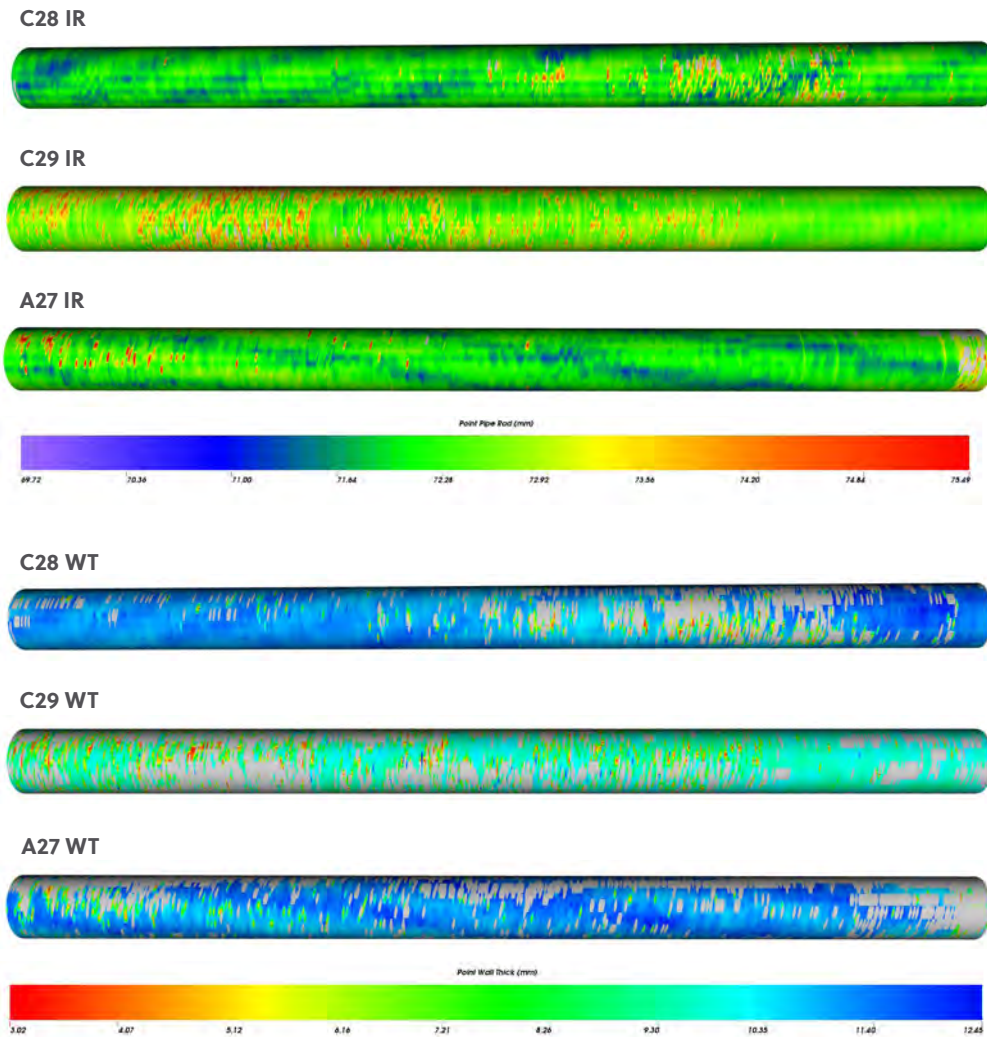
Figure 2: C-Scan images displaying internal radius (top) and wall thickness measurements (bottom)

Evidence of wall loss through internal pitting corrosion was clearly apparent from the geometric tube data obtained from the inspection operations. Where an internal pit is present, a reduction in tube wall thickness corresponding to an increase in internal diameter would be expected.

**Figure 2** shows the resulting wall thickness and internal radius C-scans obtained.

In areas where the pitting was dense, i.e. high amount of pits per internal surface area, significant amounts of ultrasonic scatter were observed. The result of the scattering effect was a loss in wall thickness data at these locations. This can be seen as the grey shaded areas in the C-scans shown in **Figure 2**.

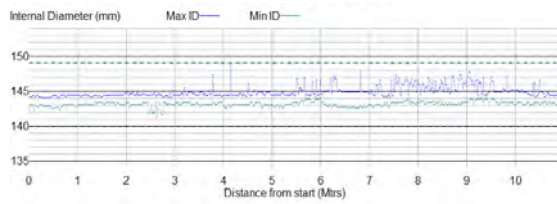
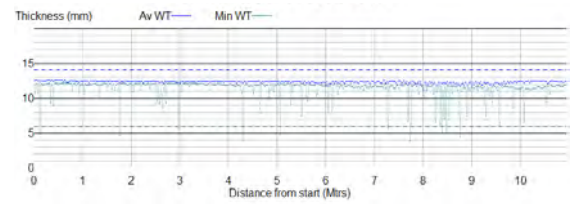
The corresponding linear graphical plots displayed an obvious pattern, consistent with internal pitting. The wall thickness and internal diameter data obtained within the areas of pitting showed a high standard deviation from the nominal values, indicating a variety of pit depths. **Figure 3** shows the typical graphical plots obtained from the three tube sections.

| Tube Reference | Average Wall Thickness | Minimum Wall Thickness | Minimum WT Axial Location | Maximum Wall Loss |
|---|---|---|---|---|
| C28 | 12.4 | 3.8 | 7.6 | 7.2 |

| Tube Reference | Average Internal Diameter | Minimum Internal Diameter | Minimum ID Axial Location | Maximum Internal Diameter | Maximum ID Axial Location |
|---|---|---|---|---|---|
| C28 | 144.1 | 141.3 | 2.6 | 149.1 | 4.1 |

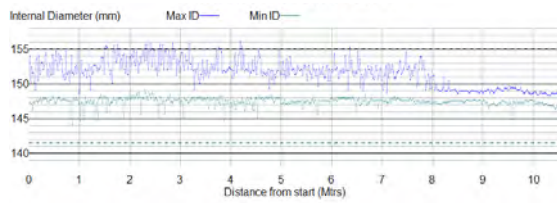
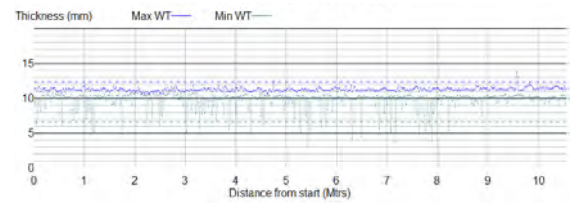
Section C29 showed the most severe pitting of the three sections tested. The damage was distributed throughout the full length of tubing, with a minimum wall thickness of 3.0mm measured. Data tables summarizing the wall thickness and internal diameter measurements obtained can be seen in **Tables 2** and **3**.

| Tube Reference | Average Wall Thickness | Minimum Wall Thickness | Minimum WT Axial Location | Maximum Wall Loss |
|---|---|---|---|---|
| C29 | 10.4 | 3.0 | 5.4 | 7.9 |

| Tube Reference | Average Internal Diameter | Minimum Internal Diameter | Minimum ID Axial Location | Maximum Internal Diameter | Maximum ID Axial Location |
|---|---|---|---|---|---|
| C29 | 147.2 | 142.7 | 10.5 | 155.0 | 1.5 |

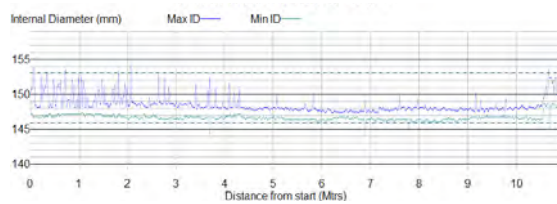
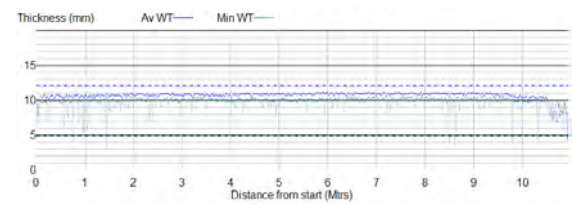
| Tube Reference | Average Wall Thickness | Minimum Wall Thickness | Minimum WT Axial Location | Maximum Wall Loss |
|---|---|---|---|---|
| A27 | 10.7 | 3.1 | 1.4 | 7.9 |

| Tube Reference | Average Internal Diameter | Minimum Internal Diameter | Minimum ID Axial Location | Maximum Internal Diameter | Maximum ID Axial Location |
|---|---|---|---|---|---|
| A27 | 147.6 | 143.9 | 10.9 | 155.6 | 10.9 |

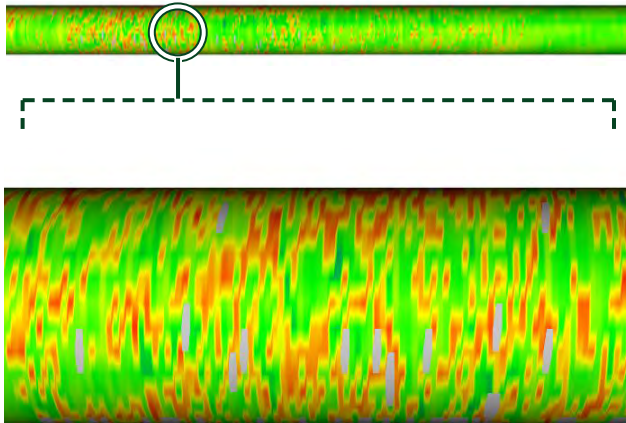
Figure 4 shows an example of the pitting detail observed in Section C29.

**Figure 4: C-Scan identifying an area of dense internal pitting in Section C29**
