Diametric growth detection on reactor charge heater radiant tubing

CASE STUDY

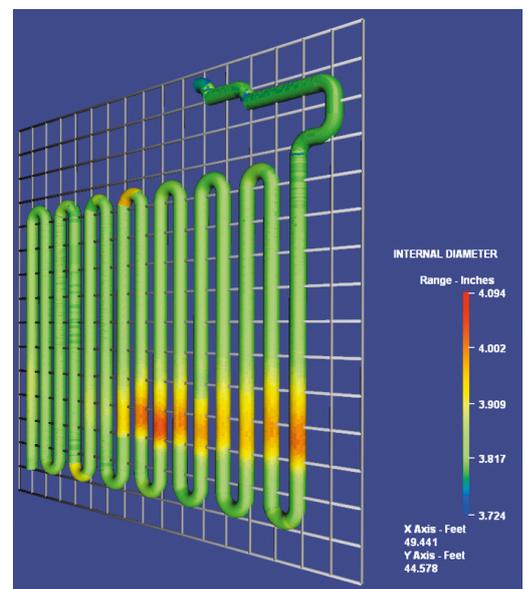
Significant diametric abnormalities were identified within the radiant coils of passes 1, 2 and 3. These abnormalities were more abundant in Pass 2, with diametric growth up to 4.7% (Pass 2, Tube 7) observed. This phenomenon was clearly visible in the 3D C-Scan and accompanying graphical plots (Figures 2, 4(a) & 4(b)). The diametric anomalies were considered to be “irregular” due to the consistent swelling around the full circumference of the tubes, as opposed to ovality or localized bulging on the fire side of the pipe-work. The tube wall thickness was seen to be constant throughout the radiant tubing, with minimal deviation from the nominal value. This can be seen in the graphical plot shown in Figures 3 and 4(c).

Figure 2: Pass 2 Internal Diameter 3D C-Scan showing diametric growth in Radiant Coil 2

Following the Inspection, the tubes that were identified as damaged were removed upon Cokebusters advice. All defect quantification and location was confirmed by the client, who remarked that this damage would almost certainly have gone undetected using conventional NDT methodologies.

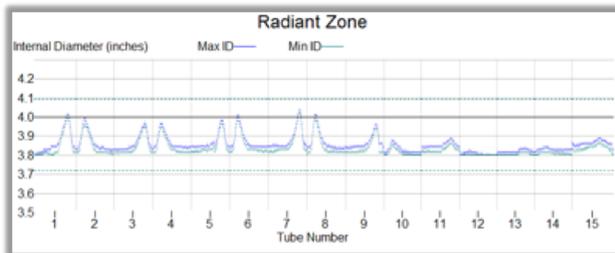
Figure 4: Graphical plots showing (a) Diametric increase in Radiant Tubes 5-9 (Inclusive), (b) Average diametric growth in radiant tube 5 and (c) Wall thickness profile along radiant tube 5
