# External high temperature oxidation

## in a vacuum distillation furnace

CASE STUDY

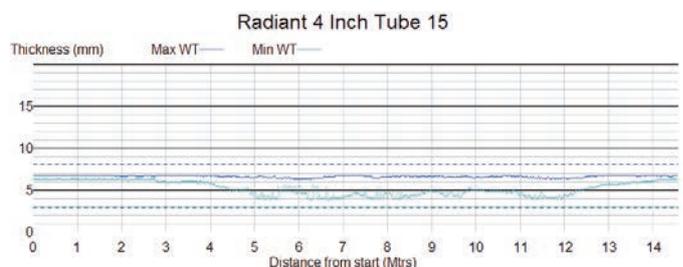
Figure 2: Graphical plots showing the correlation of internal diameter and wall thickness within a heat-affected tube.

A similar pattern of wall loss was observed in all 8 of the radiant 4-inch sections of tubing, with Pass G containing the most severe damage. This wall loss was particularly pronounced within the tubes located at the middle areas of each coil (Tubes 11 to 21, Figure 2). Correlation with the internal radius measurements obtained from the intelligent pig confirmed that the wall loss was predominantly external. After consultation with the Cokebusters mechanical decoking Technicians, it was verified that these particular radiant areas also showed the highest level of internal coke contamination. Figure 3 shows a cross-sectional tube image taken from one of the affected areas. The data table below the image clearly identifies the extent and orientation of the wall loss at this particular axial location. Figure 4 displays the 3D wall thickness C-scan obtained from Pass G.

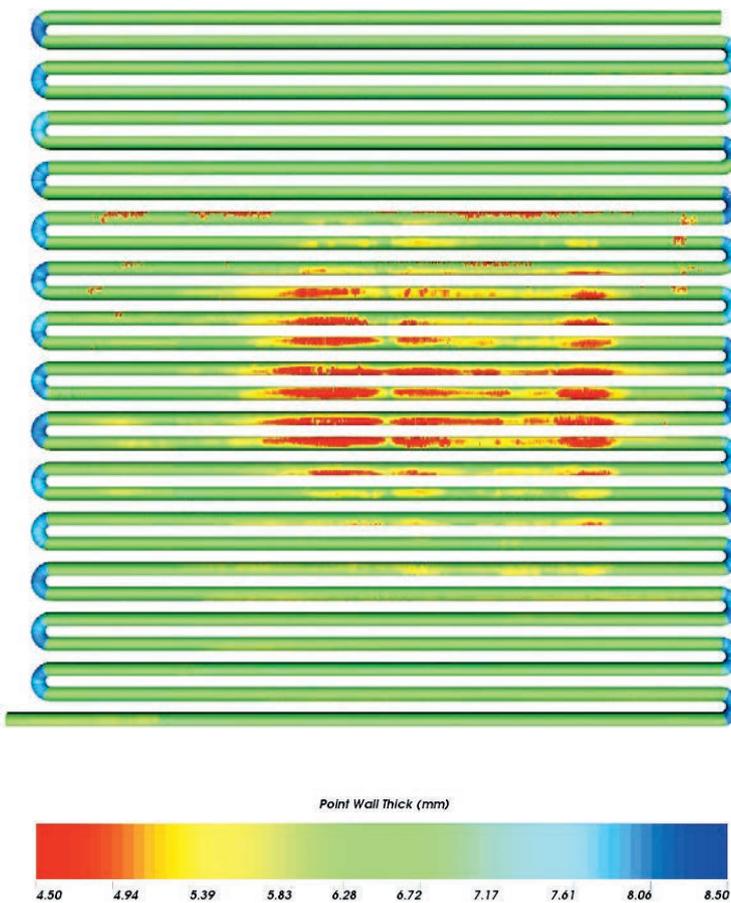
Figure 4: 3D Wall Thickness C-Scan

Following consultation with Refinery Engineers, it was hypothesized that the damage mechanism was due to localized flame impingement, which was ultimately caused by burner misalignment. The elevated skin temperatures within these areas accelerated internal coke build-up at the heat-affected zones, which was confirmed by the Cokebusters mechanical decoking Technicians. The insulating coke layers further increased the skin temperatures, which ultimately led to severe external oxidation.

Following the Inspection, the tubes that were identified as damaged and below the calculated corrosion allowance were removed upon Cokebusters advice. All defect quantification and location was confirmed by the client using manual UT methods.

Burner alignment was reviewed and adjusted accordingly. Regular mechanical decoking and intelligent pigging operations were also recommended to eliminate the potential for similar future damage. It was also suggested by the client that no other commercially available intelligent pigging system has the capability of navigating plugged headers with similar geometry to those found within these radiant coils, making the Merlin inspection system a unique intelligent pigging service.
