# Internal Pitting Corrosion

## Background

**Cokeusters Ltd** were requested by a reputable global group of refining companies to carry out a Merlin™ in-line inspection of three separate sections of 6-inch furnace tube. The three sections of tubing had been removed from the furnace due to the presence of severe internal pitting corrosion. The aim of the investigation was to observe the geometric data acquired from the Merlin intelligent pig within these corroded areas. The three sections of tubing were sent to the Cokebusters Technology Centre (UK), where the tests were conducted. The inspection was carried out using the patented Merlin™ Intelligent In-line inspection, or intelligent pigging system for accurate geometric assessment of the tube sections.

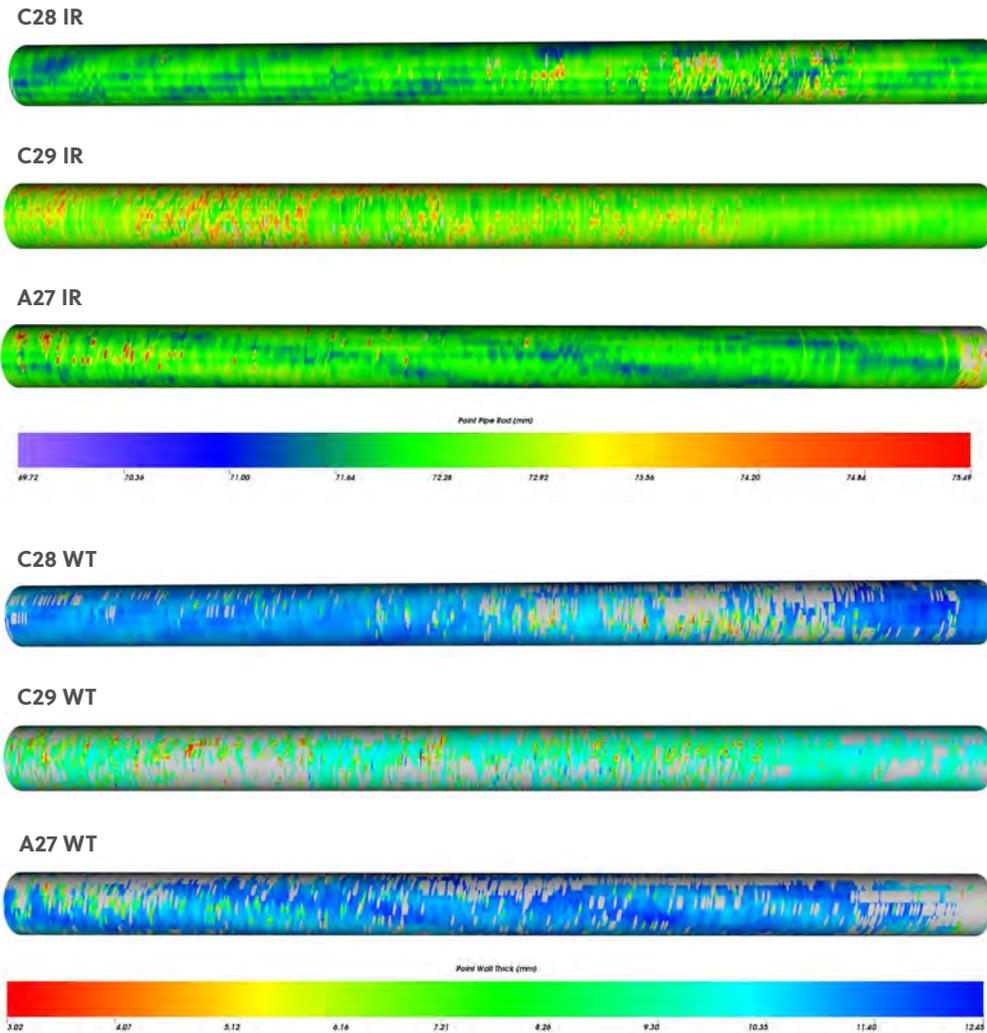
Figure 2: C-Scan images displaying internal radius (top) and wall thickness measurements (bottom)

Evidence of wall loss through internal pitting corrosion was clearly apparent from the geometric tube data obtained from the inspection operations. Where an internal pit is present, a reduction in tube wall thickness corresponding to an increase in internal diameter would be expected.

**Figure 2** shows the resulting wall thickness and internal radius C-scans obtained.

In areas where the pitting was dense, i.e. high amount of pits per internal surface area, significant amounts of ultrasonic scatter were observed. The result of the scattering effect was a loss in wall thickness data at these locations. This can be seen as the grey shaded areas in the C-scans shown in **Figure 2**.

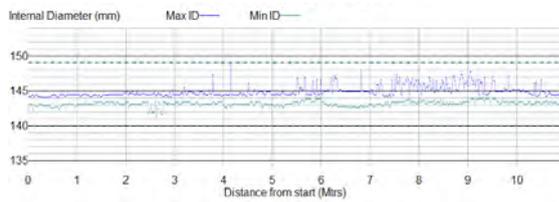
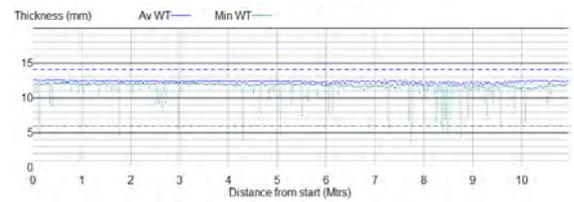
## C28

The corresponding linear graphical plots displayed an obvious pattern, consistent with internal pitting. The wall thickness and internal diameter data obtained within the areas of pitting showed a high standard deviation from the nominal values, indicating a variety of pit depths. **Figure 3** shows the typical graphical plots obtained from the three tube sections.

**Figure 3: Linear graphical plots showing average/minimum wall thickness & maximum ID with respect to tube length**

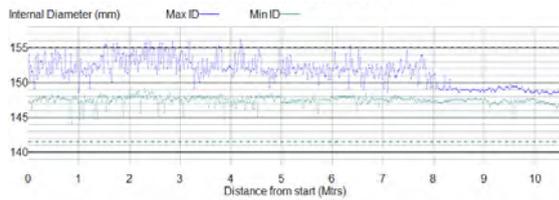
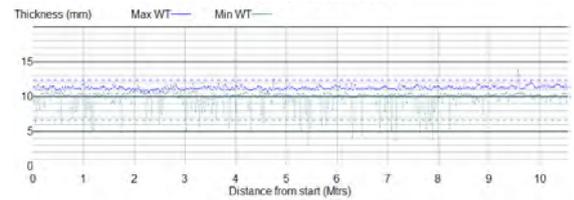
## C29

Section C29 showed the most severe pitting of the three sections tested. The damage was distributed throughout the full length of tubing, with a minimum wall thickness of 3.0mm measured. Data tables summarizing the wall thickness and internal diameter measurements obtained can be seen in **Tables 2** and **3**.

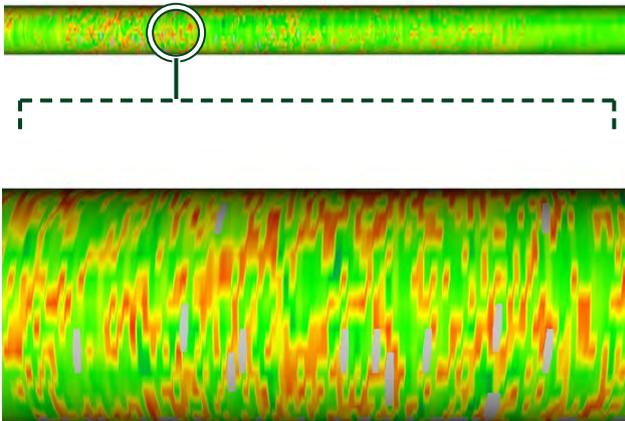
**Figure 4: C-Scan identifying an area of dense internal pitting in Section C29**

**Figure 4** shows an example of the pitting detail observed in Section C29.

ultrasound signal can be deflected, causing a loss in the reflected signal. This will result in a zero reading at this point. This loss in wall thickness data is therefore proportional to the pit density within the tube.

ultrasonic based measuring system using this frequency of single element immersion transducer. The key objective to using an intelligent pigging system for furnace tube assessment is to accurately locate anomalies and flaws. The identified anomalies can then be further investigated/assessed using alternative methodologies such as handheld UT measurement and other corrosion mapping techniques.
