Cokebusters were engaged to carry out inspection on the radiant section of an atmospheric crude heater, in Texas, as part of a refinery scheduled maintenance turnaround in 2018.

Inspection Results

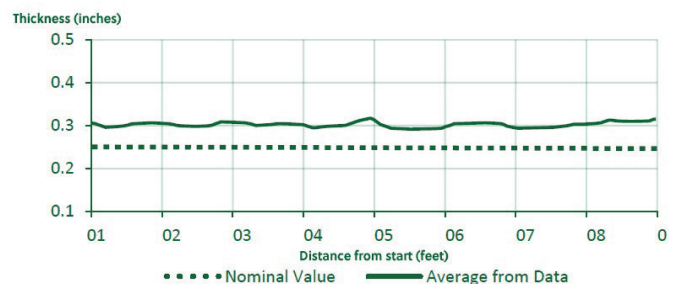
Graph 1 – Average Wall Thickness of Radiant Tube 1

From the data it was clear that the average wall thickness for each tube was in fact significantly higher than the specified nominal values for the replacement tubes.

The specification sheet for these tubes gave dimensions of 4.5" O.D x 0.25" M.W. Inspection data showed that the average wall thickness across all of the tubes was 0.305". This represented an increase of some 18%.

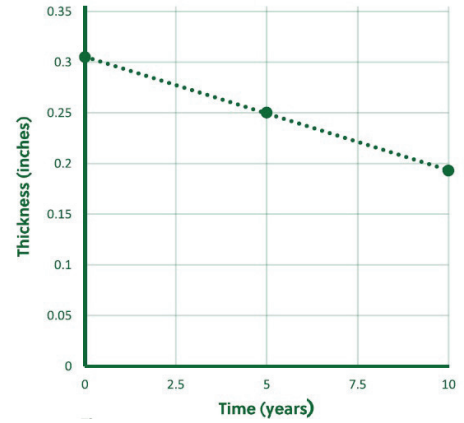
Graph 2 shows the average wall thickness for the coil from three separate Smart Pig inspections carried out over ten years.

It is only by having the benefit of a baseline inspection it can be seen that, during those five years, the condition of the coil had deteriorated from an average thickness of 0.305", to 0.25". This represents a wall loss of 0.055", or 18%.

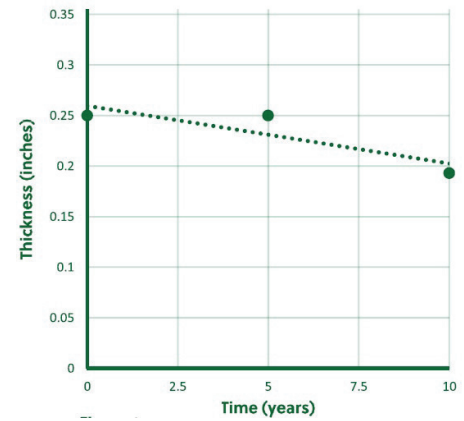
Graph 3 demonstrates the same results, except the average wall thickness value obtained from the baseline inspection has been replaced with the specified nominal thickness for the coil at T=0. As the 'best fit' lines show, this can have a dramatic effect on corrosion rates. Graph 3 shows a corrosion rate of 0.004" per year. In Graph 2, with the benefit of the baseline inspection, a corrosion rate of 0.011" per year has been calculated.

In Graph 3, where the first Smart Pig inspection was carried out after 5 years of the new coil being in service, the assumption could be made that the coil had not deteriorated from its original condition.

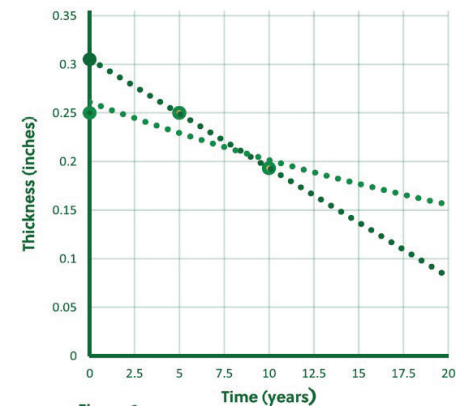
Graph 4 demonstrates the effect this can have on corrosion rates forecasted over 20 years.

As Graph 4 illustrates, had the coil continued to deteriorate at the rate it had over the first five years of it being in service, by Year 20, wall thickness would have been as low as 0.08". Consequently, the decision to delay further Smart Pig inspections could have had catastrophic results.
