Background

Cokebusters was contracted by a facility in Texas to carry out an In-Line Inspection (ILI) of a Reactor Charge Heater, as part of a scheduled maintenance turnaround.

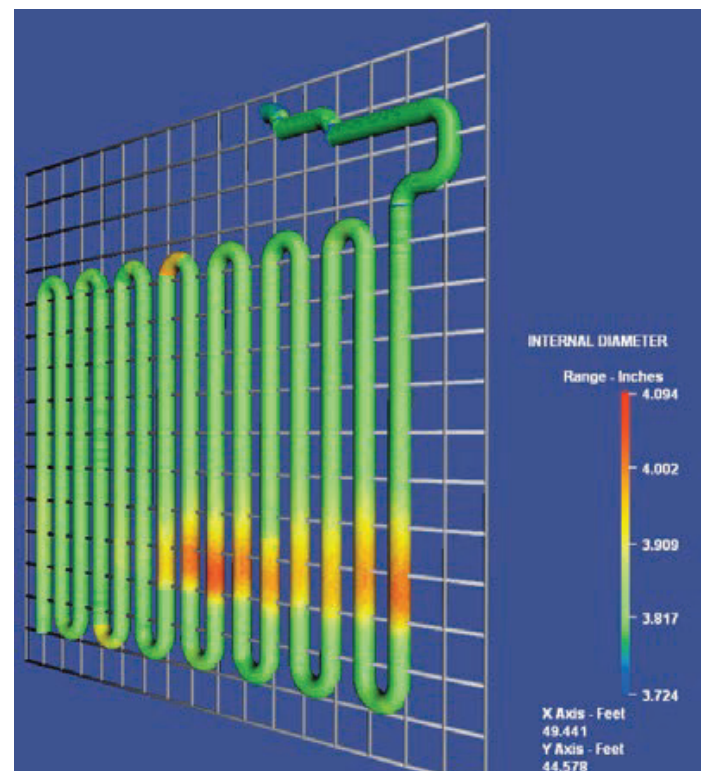
These abnormalities were more abundant in Pass 2, with diametric growth up to 4.7% (Pass 2, Tube 7) observed. This phenomenon was clearly visible in the 3D C-Scan and accompanying graphical plots (Figures 2, 4(a) & 4(b)).

The diametric anomalies were considered to be "irregular" due to the consistent swelling around the full circumference of the tubes, as opposed to ovality or localized bulging on the fire side of the pipe-work.

Figure 2: Pass 2 Internal Diameter 3D C-Scan showing diametric growth in Radiant Coil 2

Scanning Electron and Optical microscopy confirmed the presence of ferrite and martensite in the heat affected areas, indicating that the tubes were exposed to skin temperatures in excess of 750°C, with a high rate of cooling experienced. The micro-hardness measurements obtained in these areas further confirmed exposure to excessive temperatures and were attributed to strain hardening resulting from plastic deformation from exposure to elevated operating temperatures and pressures. Overheating reduced the tube strength sufficiently that the internal stresses exceeded the yield strength of the tubes, which ultimately led to diametric swelling.

Upon discussion with the client, it was concluded that the radiant tubes were subjected to short-term overheating during operational shutdown, which ultimately led to the tube bulging and diametric deformation within the radiant tubing. Long-term creep damage was ruled out due to the uniform concentric swelling, accurate burner alignment and known historic operating temperatures outside of the creep regime.

Following the inspection, the tubes that were identified as damaged were removed upon Cokebusters' advice. All defect quantification and location was confirmed by the client, who commented that this damage would almost certainly have gone undetected using conventional NDT methodologies.

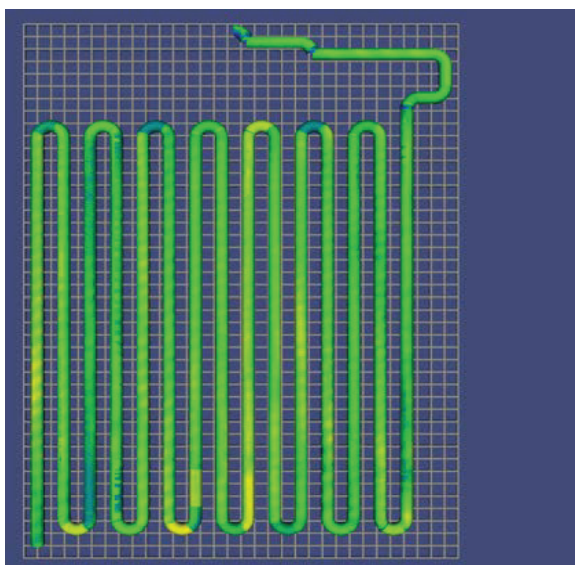
The tube wall thickness was seen to be constant throughout the radiant tubing, with minimal deviation from the nominal value. This can be seen in the graphical plot shown in Figures 3 and 4(c).

Figure 3: Pass 2 Wall Thickness C-Scan

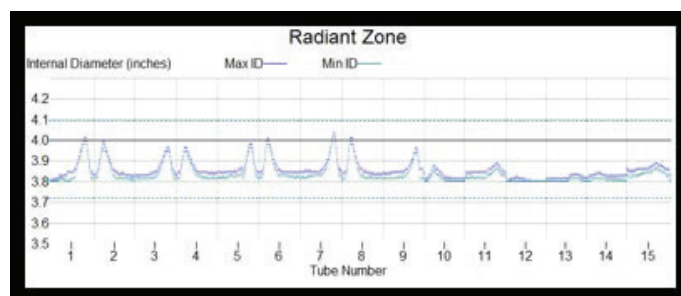
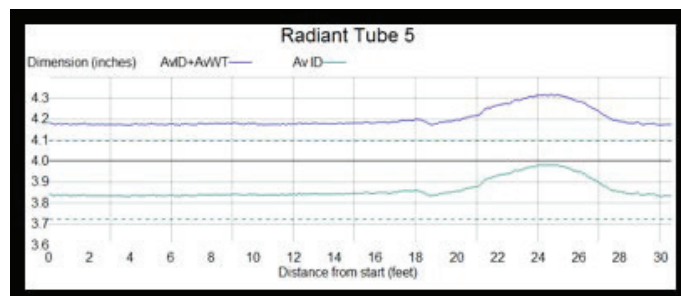
Figure 4: Graphical plots showing (a) Diametric increase in Radiant Tubes 5-9 (Inclusive), (b) Average diametric growth in radiant tube 5 and (c) Wall thickness profile along radiant tube 5
