Baseline Inspections

A CASE STUDY

Cokeusters USA were contracted by a client to carry out a **Merlin™ in-line inspection** on the radiant section of an Atmospheric crude heater as part of their scheduled maintenance turnaround in 2018. The coils that were to be inspected were newly commissioned, and had not yet entered commercial operation. Upon manufacture, seamless tubes are susceptible to various manufacturing tolerances, which can result in deviations from the specified nominal tube dimensions. To obtain a complete evaluation of tube geometry, a complete inspection of all process tubes using the **Merlin smartpig** was requested by the client.

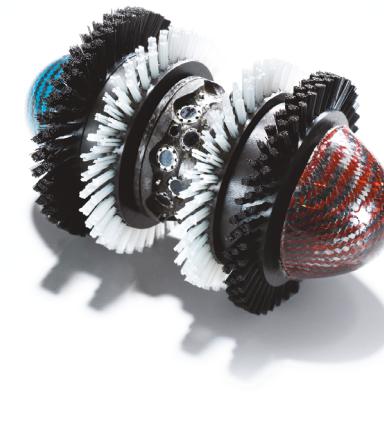
The **Merlin™ Mark IV Smartpig** is a carbon fibre, single bodied un-tethered device, which employs a series of ultrasonic transducers to measure tube wall thickness and internal radius at equally spaced circumferential locations along the full length of the heater coil, effectively scanning the process tubes for geometric abnormalities or defects. The smartpig records and stores the received data to its on-board memory, which is later uploaded via USB to a computer. The data is then automatically interpreted and analyzed by the **Merlin™ software**, which can then output various graphical images and C-scans of the process tubes. The scanner unit employs a series of custom built piezo-composite transducers, each constantly firing and receiving a complexity of rapid-fire ultrasonic pulses.

SMART PIG SPECIFICATION

Tube Diameter Range (Internal)	2.6"-12"
Wall Thickness static accuracy	0.012"
ID accuracy	±0.75% (full scale)
Axial location accuracy	2.4" (typical)
Spatial Resolution	0.3"x 0.5" (typical)
Data sampling rate	60Hz
Measurements per sample	128 (3-5") 256 (6-12")
Transducer center frequency	5MHz
Battery life before charge	8 hours
Running speed	1.0-3.0fps

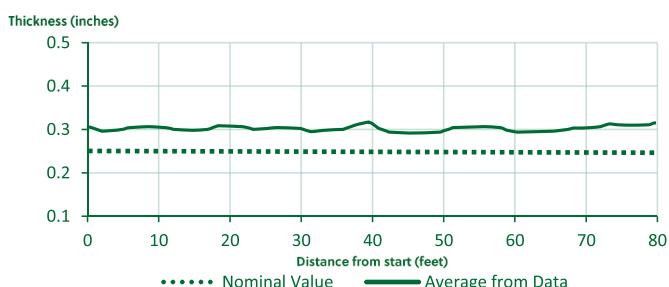
AVERAGE WALL THICKNESS OF RADIANT TUBE 1

Multiple inspection runs were carried out using the **Merlin™ smartpig** in order to confirm and validate data. Over two hundred and thirty thousand individual wall thickness measurements were recorded in each tube. From the as-obtained data it was clear that the average wall thickness for each tube was significantly higher than the specified nominal values for the replacement tubes. The specification sheet for these tubes gave dimensions of 4.5" O.D x 0.25" M.W. Inspection data showed that the average wall thickness across all of the tubes was 0.305". This represents an increase of 18%.
