Background

Cokebusters was contracted by a client to carry out an in-line inspection of an 8-Pass Vacuum Distillation Furnace as part of their scheduled maintenance turnaround.

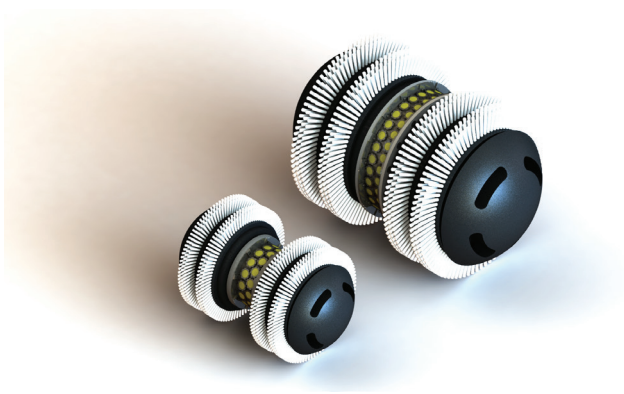
The Cokebusters' Mark IV Smart Pig is a single bodied un-tethered device, which employs a series of ultrasonic transducers to measure wall thickness and internal radius, circumferentially, along the full length of the heater coil, effectively scanning the process tubes for geometric abnormalities or defects.

Figure 1 – Example Cokebusters' Smart Pigs

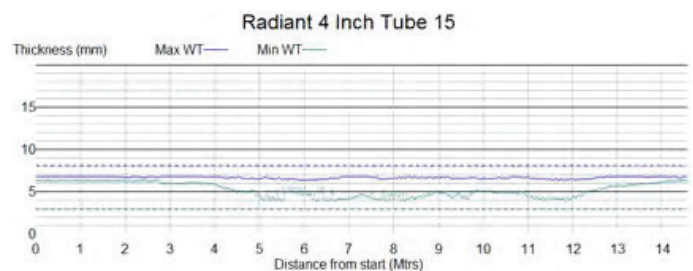
A similar pattern of wall loss was observed in all 8 of the radiant 4-inch sections of tubing, with Pass G containing the most severe damage.

This wall loss was particularly pronounced within the tubes located at the middle areas of each coil (Tubes 11 to 21, Figure 2).

Correlation with the internal radius measurements obtained from the smart pig confirmed that the wall loss was predominantly external.

Figure 2 - Graphical plots showing the correlation of internal diameter and wall thickness within a heat-affected tube.

Following the inspection, the tubes that were identified as damaged and below the calculated corrosion allowance were removed upon Cokebusters advice. All defect quantification and location was confirmed by the client using manual UT methods.

Burner alignment was reviewed and adjusted accordingly. Regular mechanical decoking and smart pigging operations were also recommended to eliminate the potential for similar future damage.

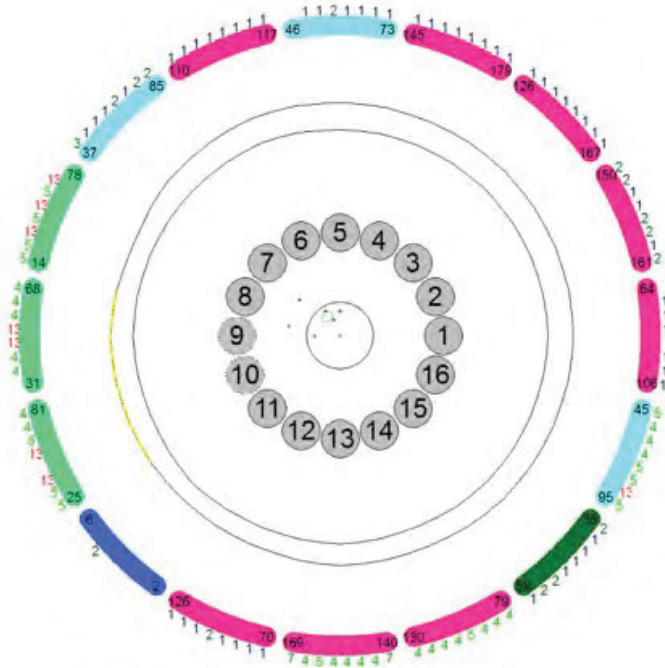
Radiant 4 Inch Tube 14

Figure 3 shows a cross-sectional tube image taken from one of the affected areas. The data table below the image clearly identifies the extent and orientation of the wall loss at this particular axial location. Figure 4 displays the 3D wall thickness C-scan obtained from Pass G.

Figure 3 - Pass 2 Wall Thickness C-Scan

Length: 14.54 Dia.: 102.3 (+507-2.0)

Wall: 6.0 (=2.0-1.5) Pos.: 8.56mtrs

Tx	IR	WT	Good	Tx	IR	WT	Good	ID
1	50.7	6.2	8,8,8,8	9	50.6	3.3	8,5,8,0	101.3
2	50.5	6.4	8,8,8,8	10	50.3	3.4	8,5,8,0	100.8
3	50.3	6.5	8,8,8,8	11	51.0	4.6	8,1,8,1	101.3
4	50.4	6.4	8,8,8,8	12	50.6	5.0	8,8,8,8	101.0
5	50.5	6.6	8,8,8,8	13	50.9	5.3	8,6,8,6	101.3
6	51.0	6.5	8,8,8,8	14	50.4	5.5	8,8,8,8	101.3
7	50.7	6.0	8,8,8,8	15	50.6	5.8	8,8,8,8	101.3
8	50.5	4.8	8,4,8,4	16	50.5	6.1	8,7,8,7	101.0
				Av		5.5		101.2

Following consultation with Refinery Engineers, it was hypothesized that the damage mechanism was due to localized flame impingement, which was ultimately caused by burner misalignment. The elevated skin temperatures within these areas accelerated internal coke build-up at the heat-affected zones.

The insulating coke layers further increased the skin temperatures, which ultimately led to severe external oxidation.

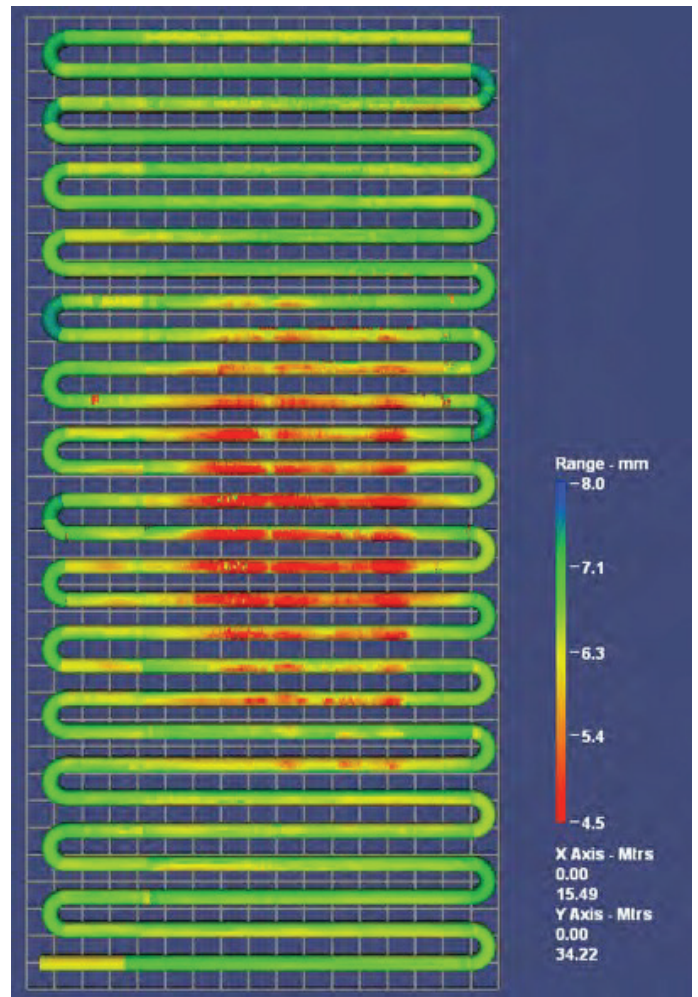
Figure 4 - Wall Thickness 3D C-Scan showing External Wall Loss in Radiant Coil 2
